# PLAT OF SURVEY

PART OF THE SOUTH LINE OF THE NORTHEAST 1/4 OF THE FRACTIONAL NORTHWEST 1/4 OF SECTION 5, TOWNSHIP 18 NORTH, RANGE 15 EAST, TOWN OF OMRO, WINNEBAGO COUNTY, WISCONSIN.

SURVEY FOR:  
DAVID WIESNER  
5187 STATE ROAD 116  
OMRO, WI 54963

PROJECT NO. 0-3032-001  
FILE 3032001POS.DWG  
THIS INSTRUMENT WAS DRAFTED BY: DSL

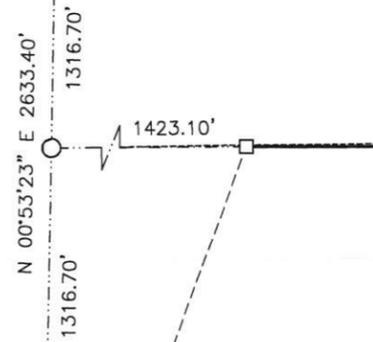
BEARINGS ARE REFERENCED TO THE WINNEBAGO COUNTY COORDINATE SYSTEM OF NAD83(1997) IN WHICH THE WEST LINE OF THE NORTHWEST 1/4 OF SECTION 5, BEARS N00°53'23"E

NORTHWEST CORNER SECTION 5, T18N-R15E ALUMINUM MONUMENT FOUND

WEST 1/4 CORNER SECTION 5, T18N-R15E ALUMINUM MONUMENT FOUND

SOUTH LINE OF THE NORTHEAST 1/4 OF THE NORTHWEST 1/4

N 89°34'20" E 1208.03'

CENTER OF SECTION 5, T18N-R15E P.K. NAIL FOUND

NORTH 1/4 CORNER SECTION 5, T18N-R15E ALUMINUM MONUMENT FOUND
