**Topographic Survey**

Part of the Southwest 1/4 of the Southeast 1/4 of Section 1,  
 Town 20 North, Range 17 East, Town of Menasha,  
 Winnebago County, Wisconsin.  
 Survey for: Maplewood Middle School District

**Martenson & Eisele, Inc.**  
 Engineering - Surveying - Planning - Architecture  
 1819 American Court  
 Neenah, WI 54956  
 (920) 731-0381  
 FAX (920) 733-8578  
 E-MAIL mail@martenson-eisele.com

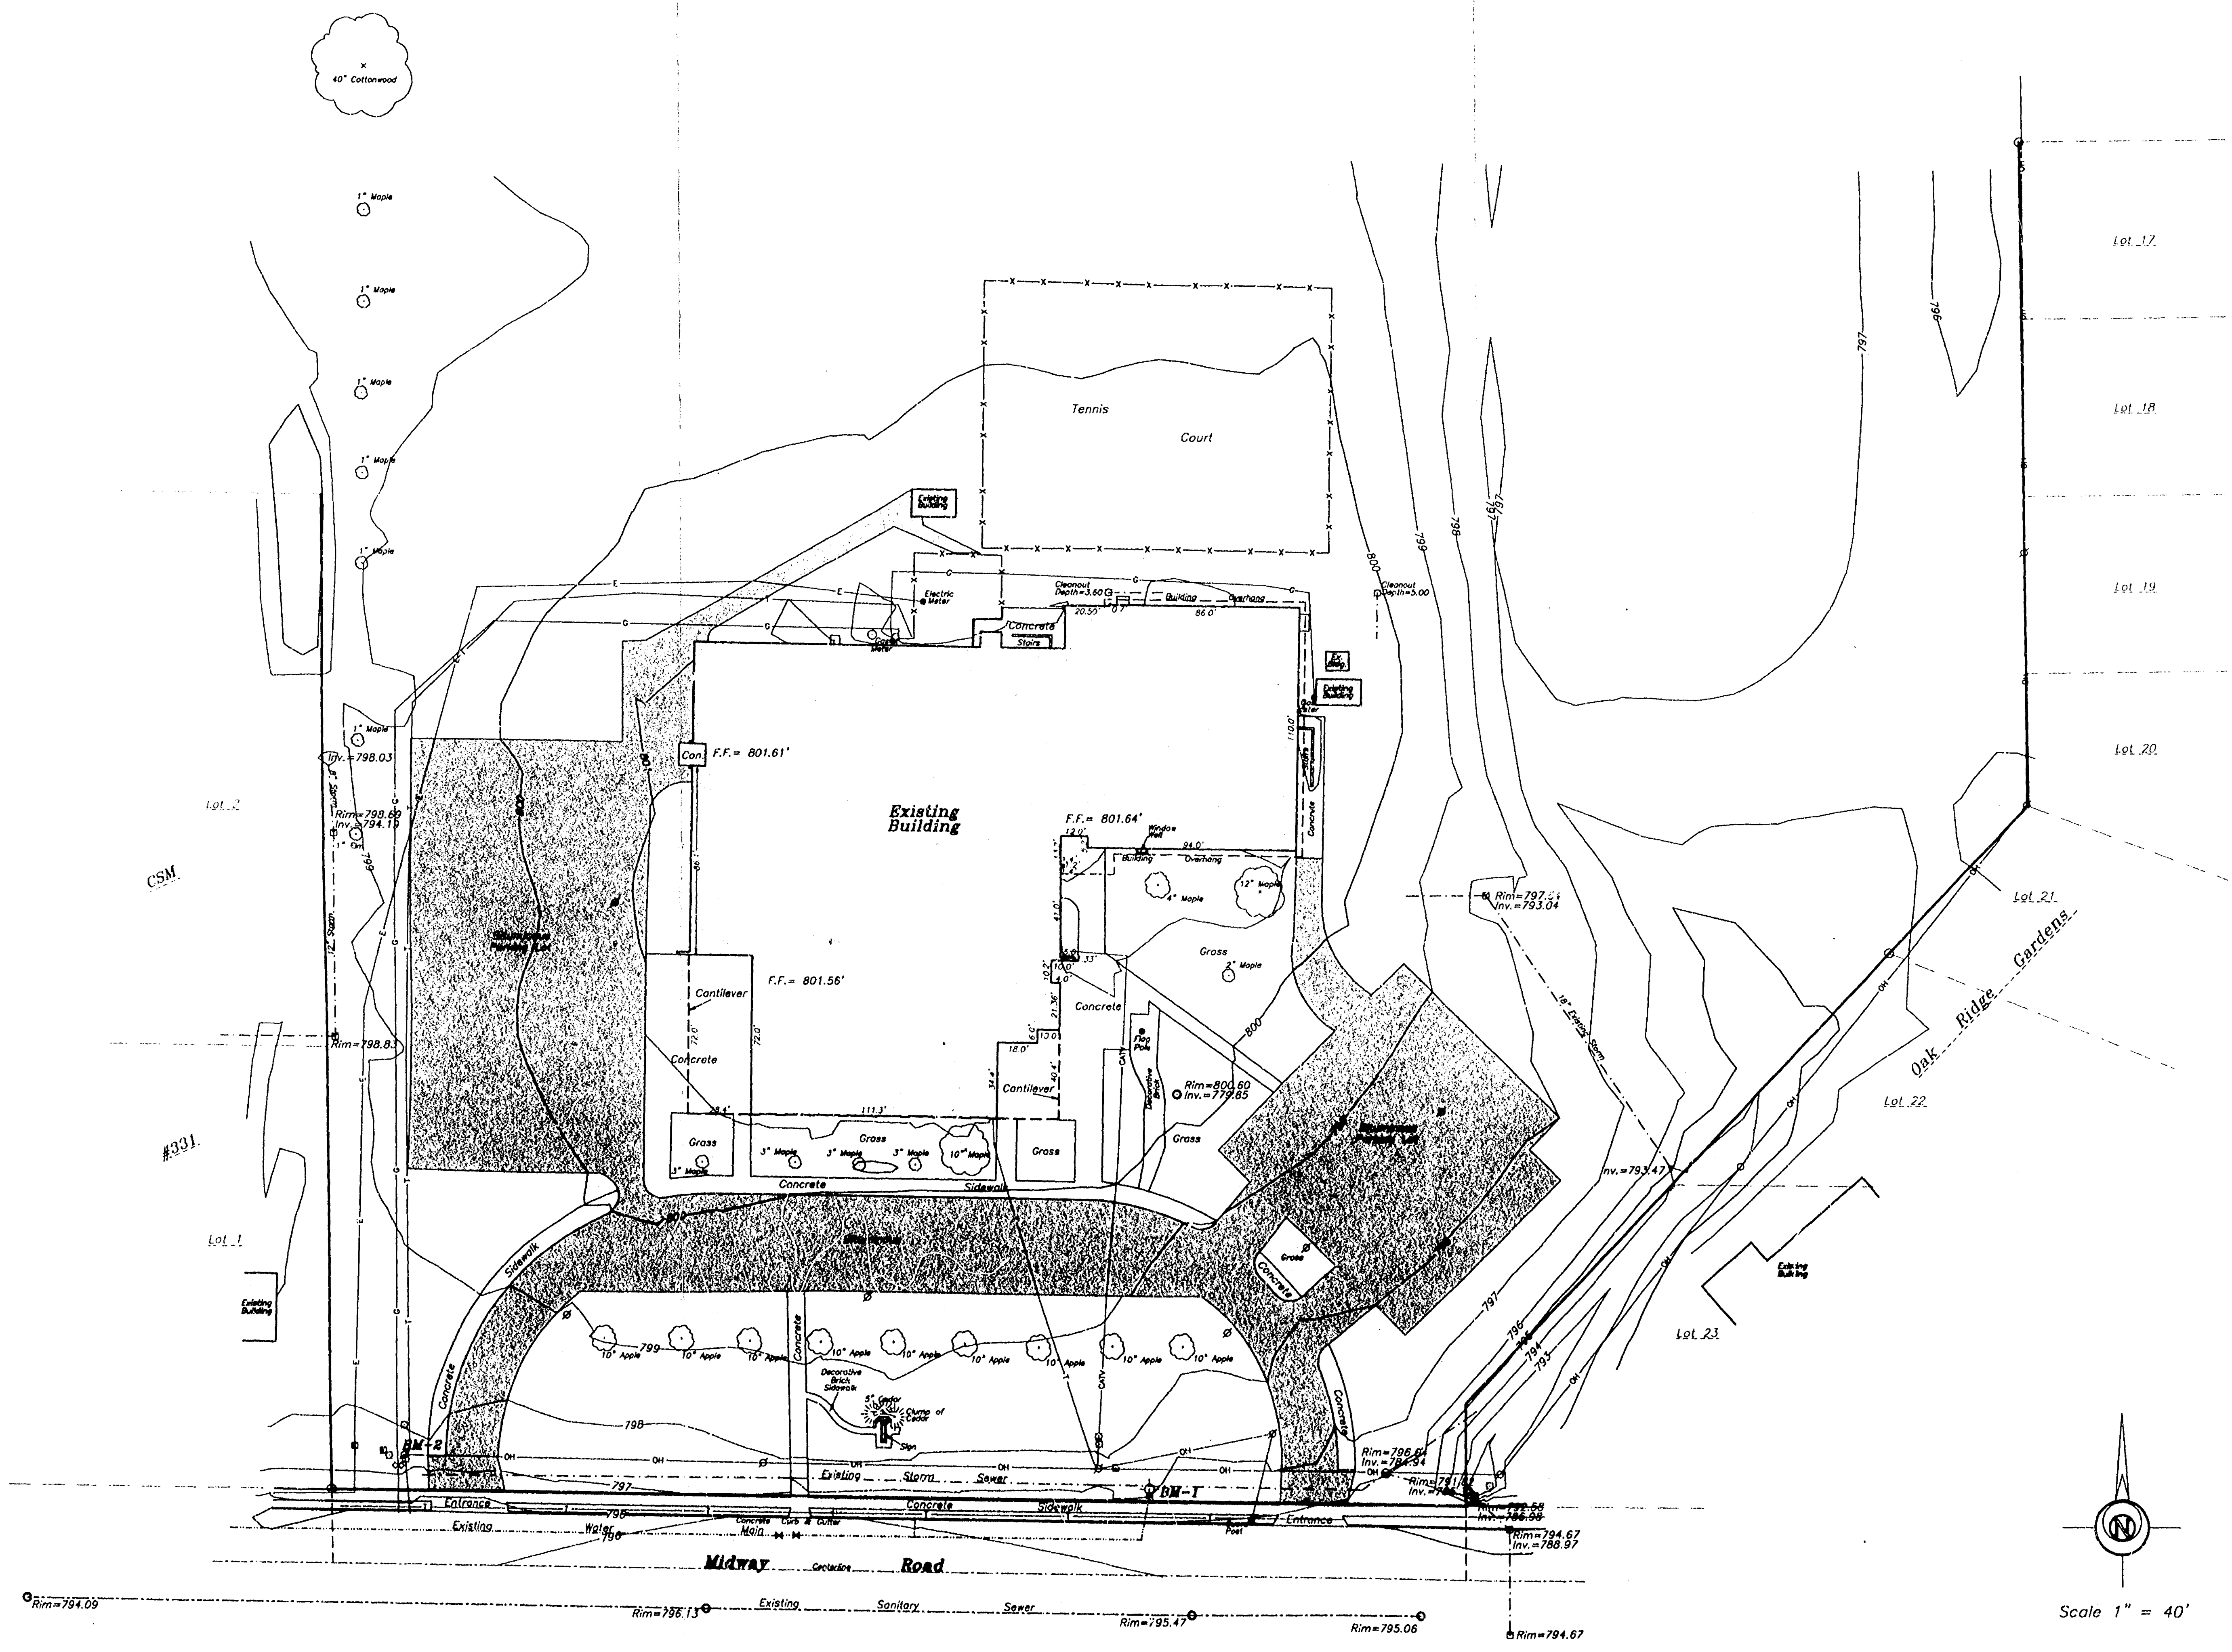
**Benchmarks**  
 BM-1 Tag bolt on hydrant located 143' +/- west of the southeast property corner. Elevation = 799.45  
 BM-2 60d nail in powerpole, 36' +/- southwest of the southwest property corner. Elevation = 798.42
